**REC-ERC-88-1**

# **EMERGENCY SPILLWAYS USING GEOMEMBRANES**

**April 1988**

**U. S. Department of the Interior  
Bureau of Reclamation**

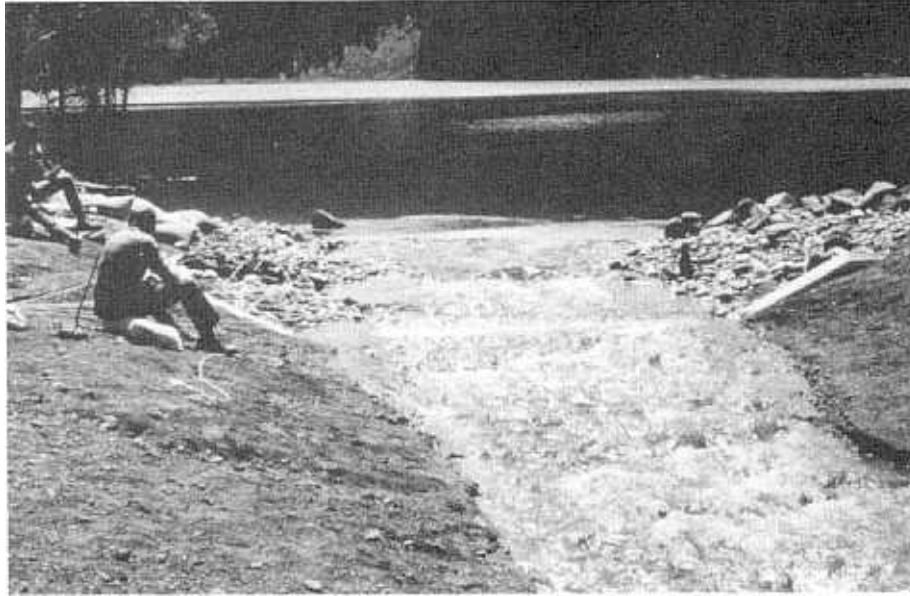
Figure 14. – Flow over spillway crest during operational test. The flow was estimated to be 0.6 to 0.7 m<sup>3</sup>/s at a maximum velocity of 6 to 8 m/s. P801-D-81376

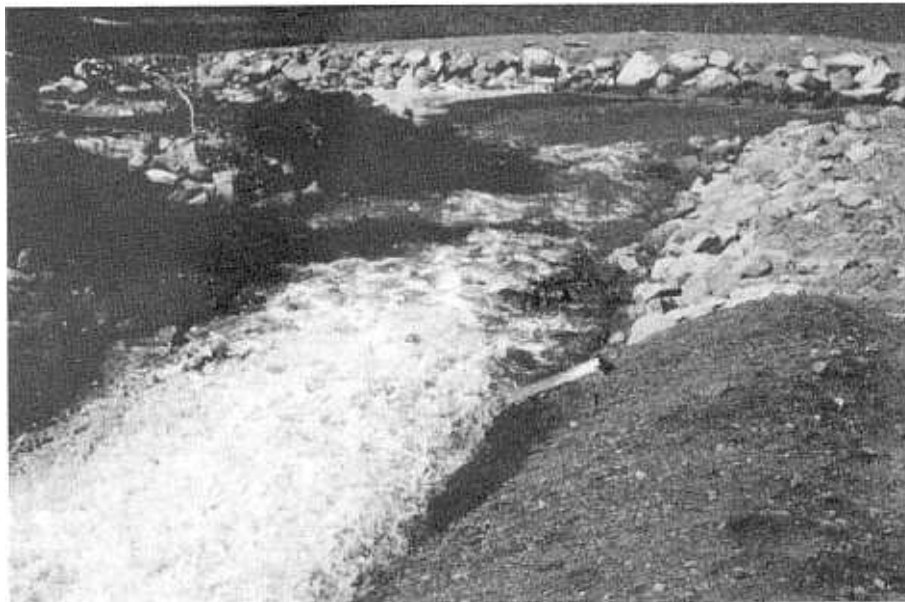
Figure 15. – Flow at downstream end of spillway. P801-D-81377

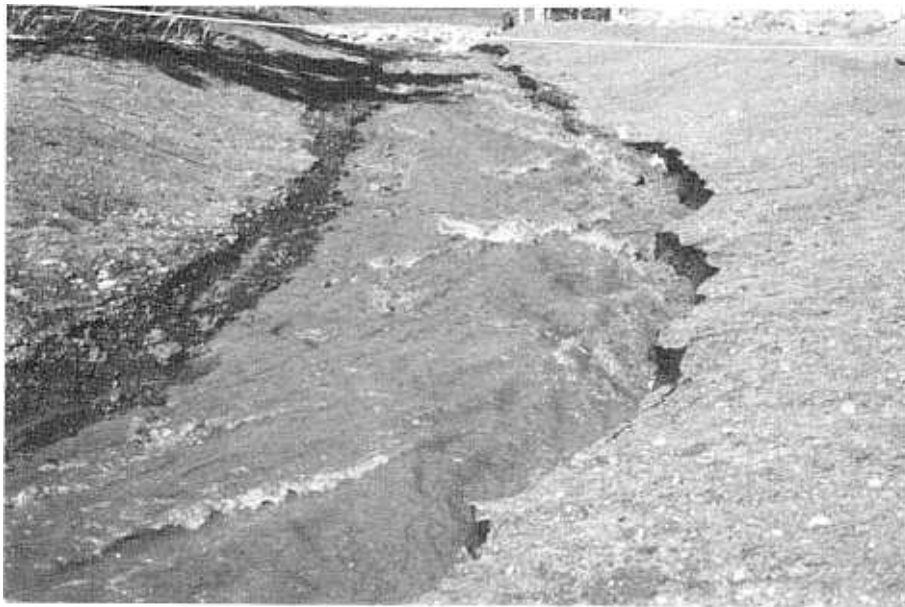
Figure 16. – Spillway during operation. P801-D-81378

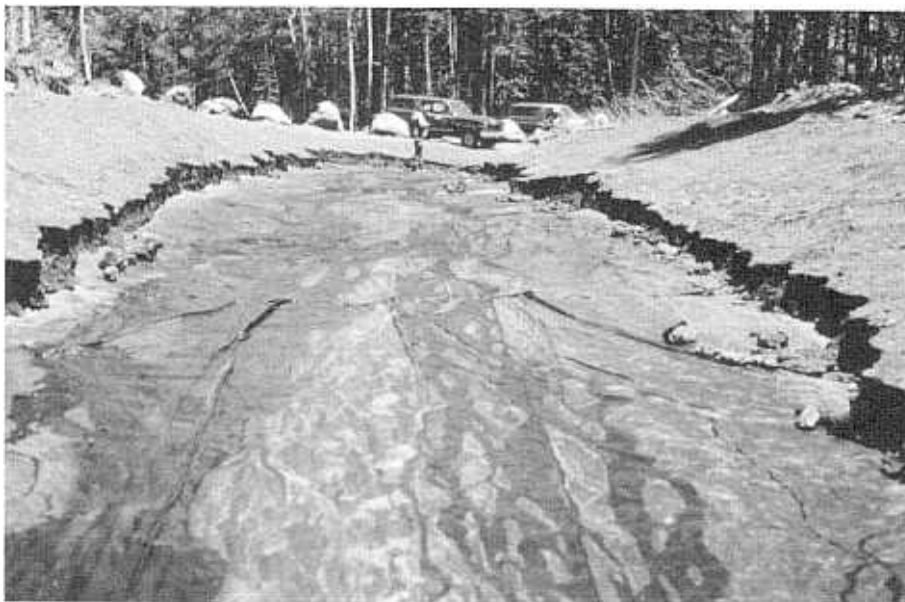
Figure 17. – Looking upstream at geomembrane-lined spillway after operational test.  
P801-D-81379

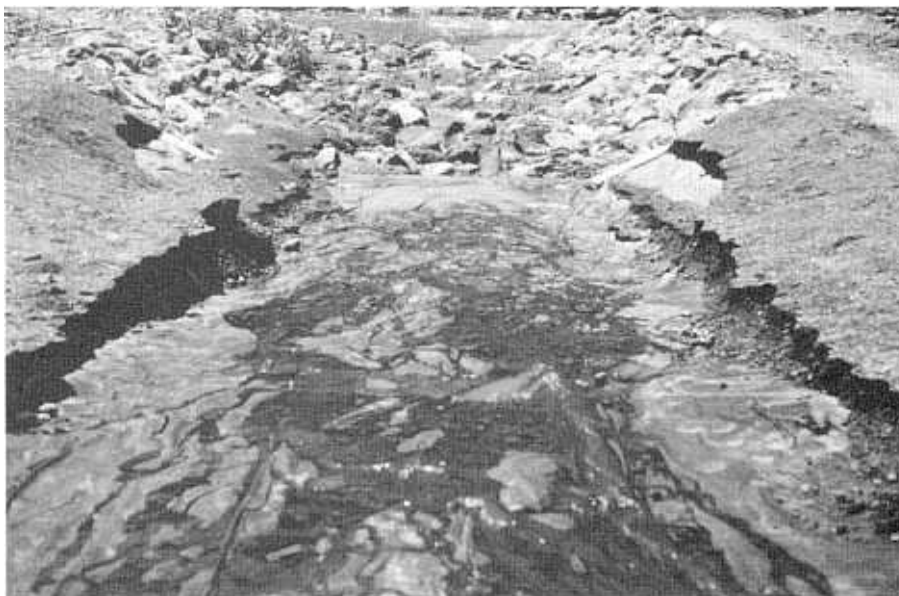
Figure 18. – Downstream end of geomembrane-lined spillway after operational test. P801-D-81380

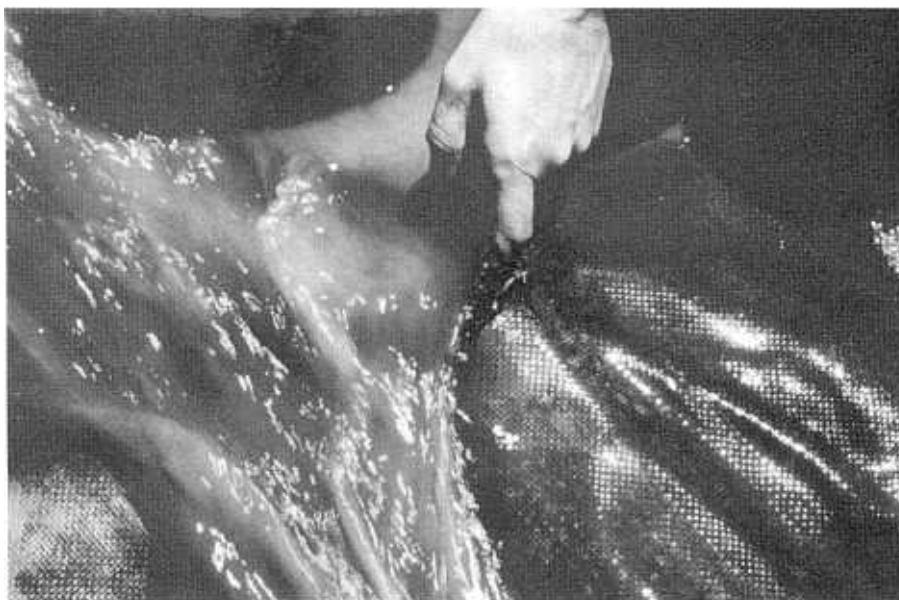
The spillway operated essentially as expected, as shown on figures 14 through 18. Early in the operation of the spillway, the soil cover was washed away until the membrane on the bottom was exposed. From then on, gradual erosion of the cover on the sides of the spillway continued for a few centimeters up the sides. Even though the flow carried much abrasive material, stones, and a few cobbles approximately 100 millimeters in diameter, little or no erosion of the membrane was observed. Only one small tear, approximately 75 millimeters long, was found, (fig. 19); it was suspected that this occurred during construction. A fist-sized stone found under the membrane at this location was probably responsible for the tear. This tear was visible during the

operation of the spillway but did not appear to increase in size.

Figure 19. – Tear in geomembrane. This tear may have occurred during the original installation. The material was in excellent condition after the operational test with only several small areas exhibiting some abrasion damage. P801-D-81381

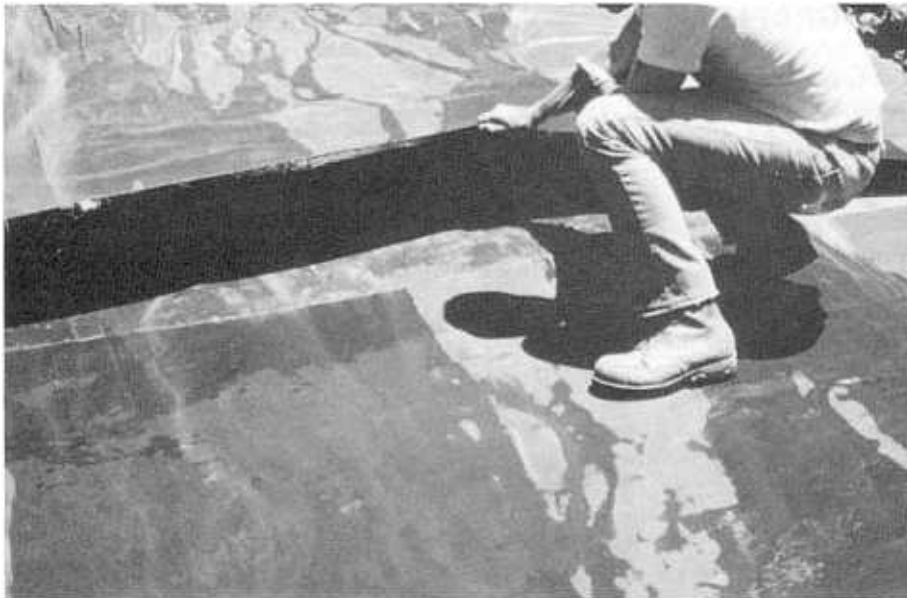
The overlapped field joints of the membrane functioned well. Immediately after the test, the overlapped joints were inspected. The exposed portion of the geomembrane was wet from the flows; however, the portion under the overlap was completely dry (fig. 20). There was no evidence of accumulated tensile strain from one sheet to another. As expected, the membrane was installed with some wrinkles to help it conform to the subgrade. These wrinkles, did not cause any problems during the operation of the spillway.

Figure 20. – Overlap seam after operational test. The geomembrane below the overlap was dry. P801-D-81382
